Smoke and Dye-Water Observation Summary

Western Run Pilot Project - Baltimore Maryland

REMARK: **DYE TEST 120 A 16**

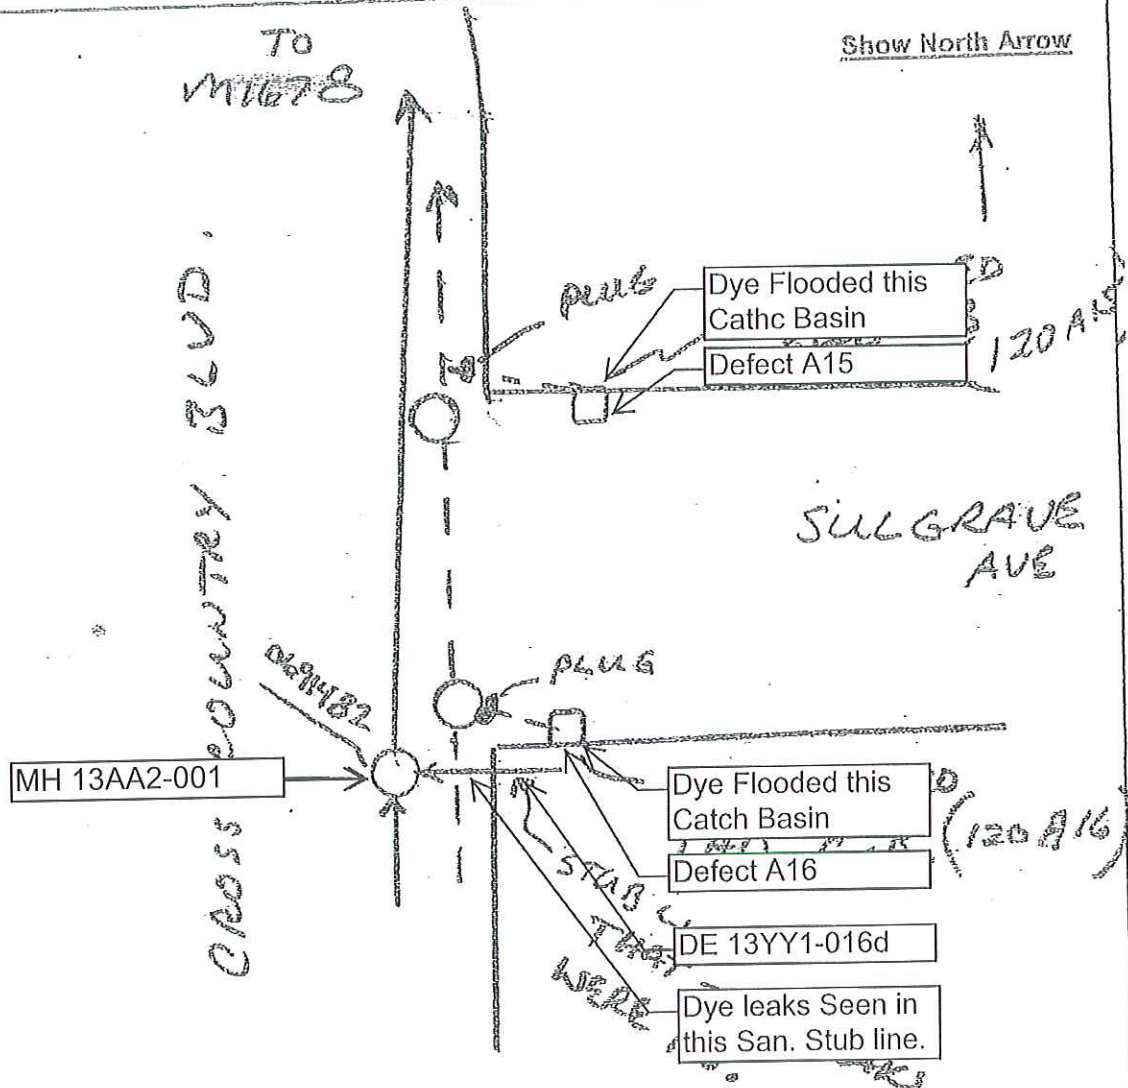
Sketch (NTS)
Dye Test 120

TEST RESULTS		SOURCES OF DYE		
1. POSITIVE	1. MAIN SEWER	5. DOWN SPOUT	9. STAIRWELL DRAIN	13. STORM DRAIN
2. NEGATIVE	2. SERVICE LINE	6. DWNSTPT CONN.	10. FOUNDATION DRAIN	14. CATCH BASIN
3. CANNOT TEST	3. TRANSITION JOIN	7. AREA DRAIN	11. BUILDING INTERIOR	15. STORM MH
	4. CLEAN OUT	8. DRIVEWAY DRAIN	12. MH FRAME/SEAL	16. STORM DITCH
Additional Comments: COULD NOT GET THE CAMERA PAST TWO FT. FOR TEST 120 A/C TO SEE THE LEAK POINT(S) (M.H. CONST. & UPWARD SLOPE. RTN)

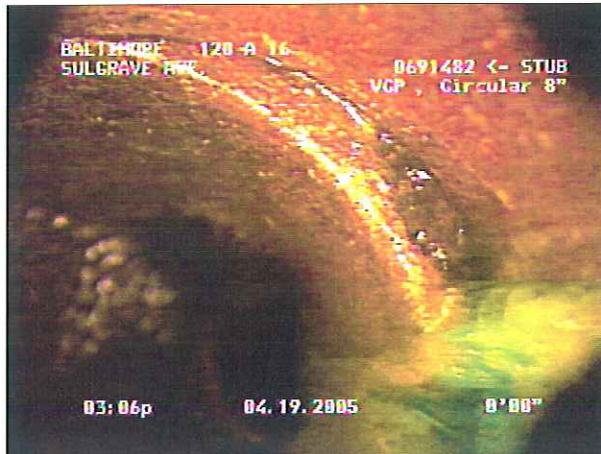
IMAGE: 26a, TAPE #: JAM 5, 00:21:33
2FT, Infiltration, Runner, at 04 o'clock

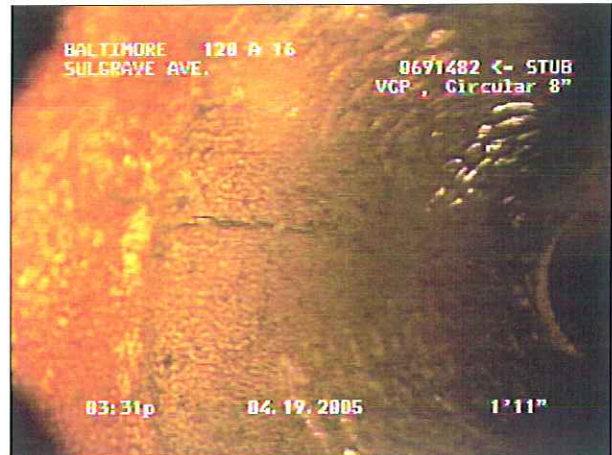
IMAGE: 28a, TAPE #: JAM 5, 00:23:04
2.2FT, Fracture, Longitudinal, Non continuous (less than 3 feet long), at 12 o'clock

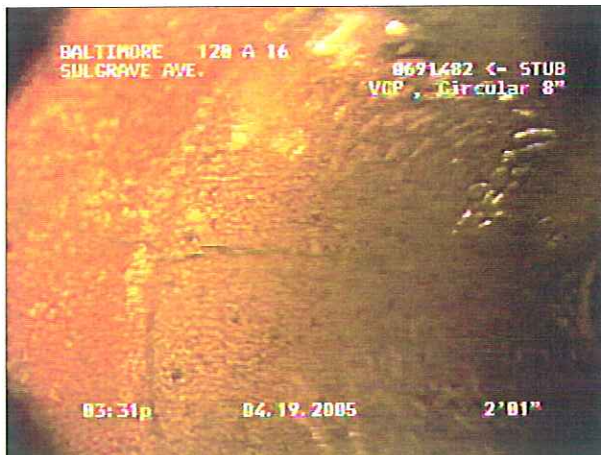
IMAGE: 29a, TAPE #: JAM 5, 00:23:04
2.2FT, Infiltration, Runner, at 12 o'clock

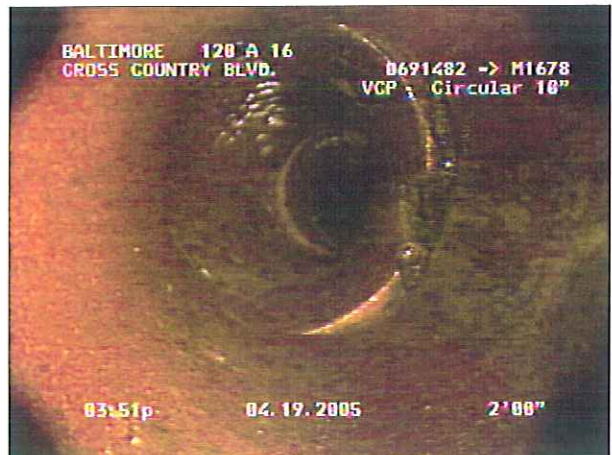
IMAGE: 34a, TAPE #: JAM 5, 00:24:25
2.25FT, THIS IS THE FLOW AFTER THE PLUG WAS RELEASED.

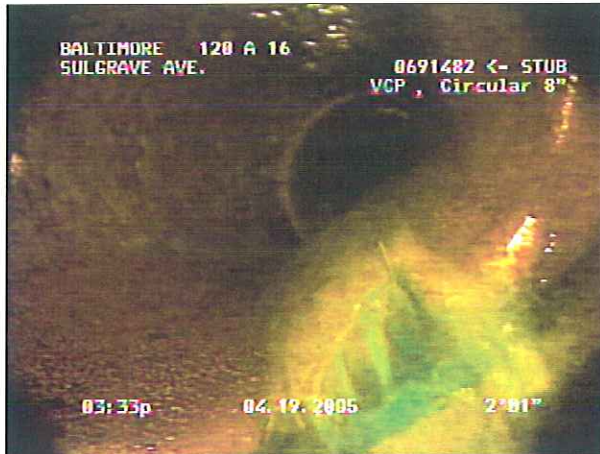
IMAGE: 30a, TAPE #: JAM 5, 00:23:04
2.3FT, Miscellaneous, Survey Abandoned, UNABLE TO GET
THE CAMERA UP THE SLOPE OF PIPE. AND CURVE INTO
M.H.

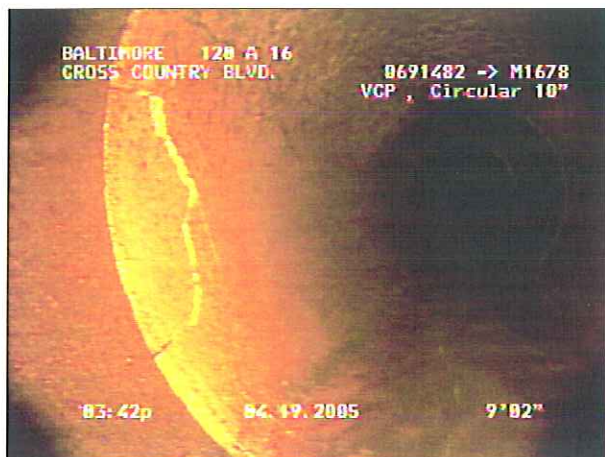
IMAGE: 32a, TAPE #: JAM 5, 00:23:27
9.16FT, Circumferential, Less than 50% of Circumference,
from 08 to 10 o'clock

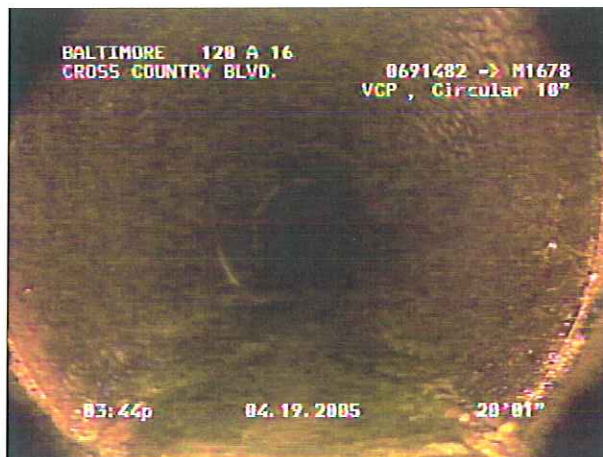
IMAGE: 33a, TAPE #: JAM 5, 00:24:26
20.12FT, Miscellaneous, Survey Abandoned, NO LEAKS
FROM DYE TEST SEEN.
